TEA FIRE SEWER STUBS

January 2009

TEA FIRE LATERAL
ABANDONMENT PROJECT

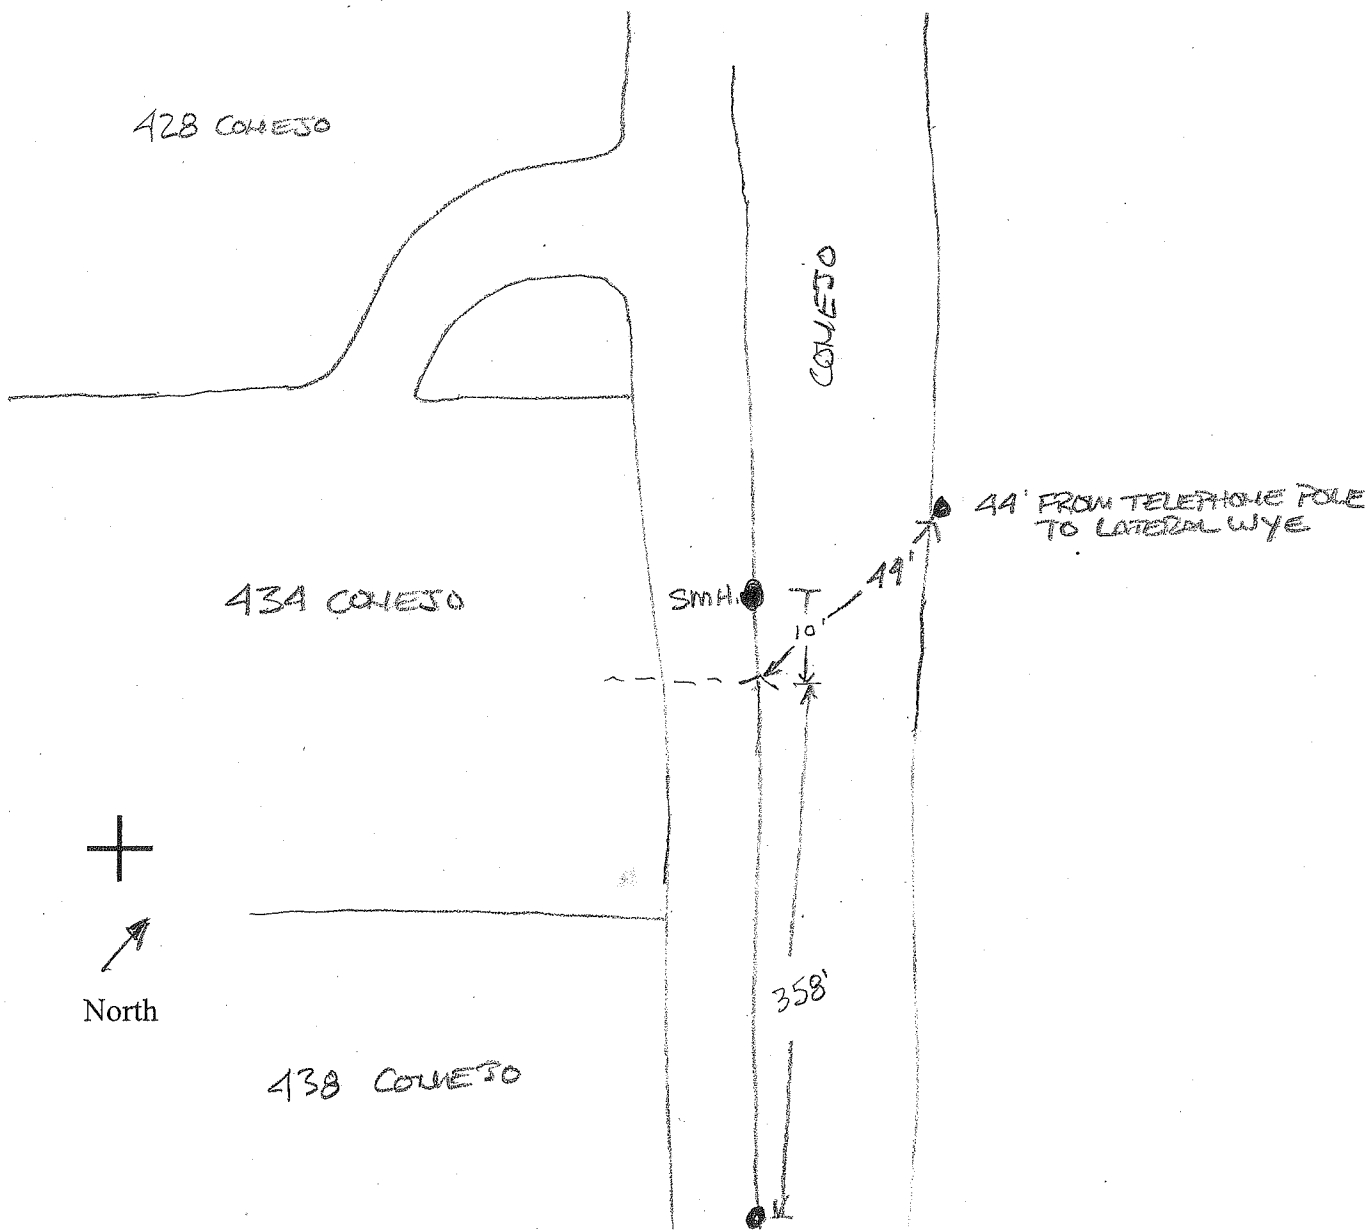
- Date: 12-30-08
- Property Address: 434 CONEJO
- Location/Address of actual excavation (also see diagram attached): SAME
- Size & material type of sewer main:
- Size & material type of lateral: 4" PVC
- Depth of Wye connection: 5'
- Distance of lateral from centerline of downstream manhole: 358'
- Excavation dimensions: 2x4
- Brief description of the site (utility conflict/traffic/soil type/other issues): NONE

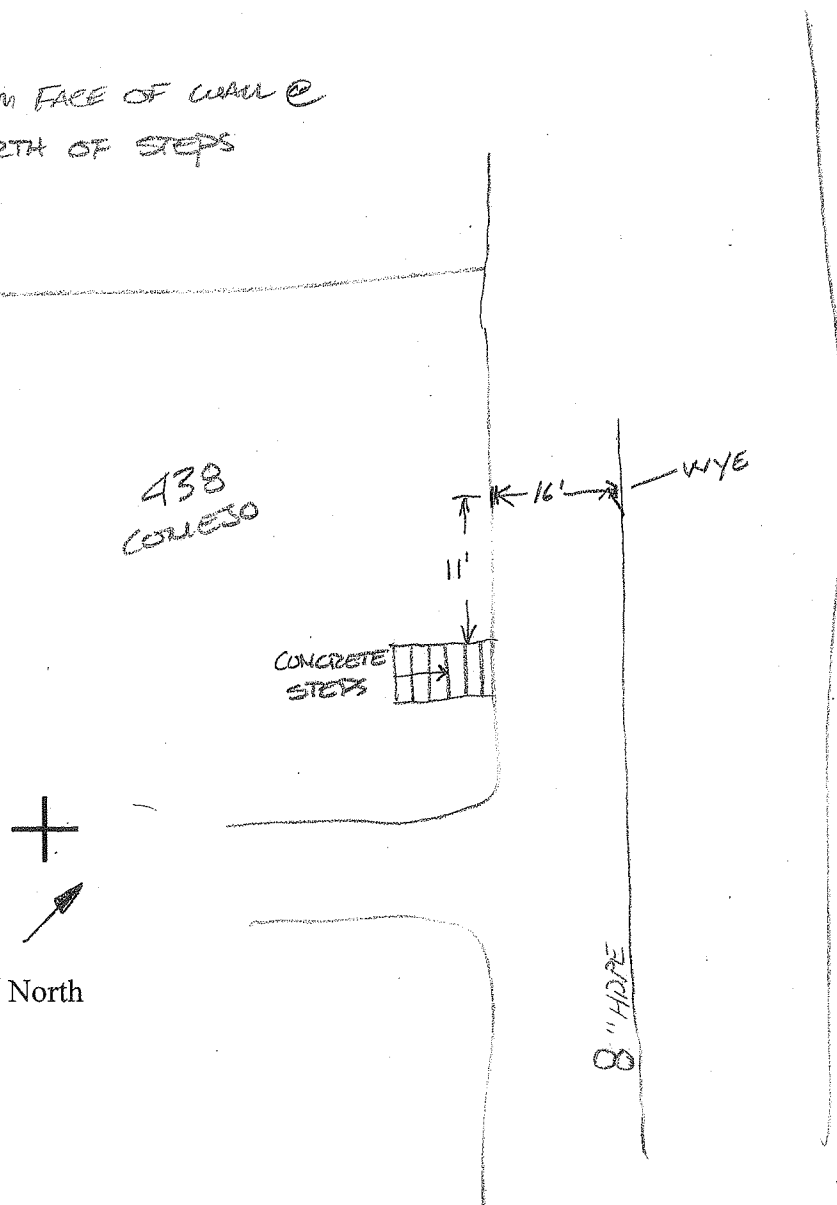
- Date: 12-29-08
- Property Address: 438 CONESO
- Location/Address of actual excavation (also see diagram attached): SAME
- Size & material type of sewer main: 6" HDPE
- Size & material type of lateral: 4" SDR
- Depth of Wye connection: 6'
- Distance of lateral from centerline of downstream manhole: 314'
- Excavation dimensions: 2 x 4
- Brief description of the site (utility conflict/traffic/soil type/other issues): NONE

14' FROM FACE OF WALL @
11' NORTH OF STEPS

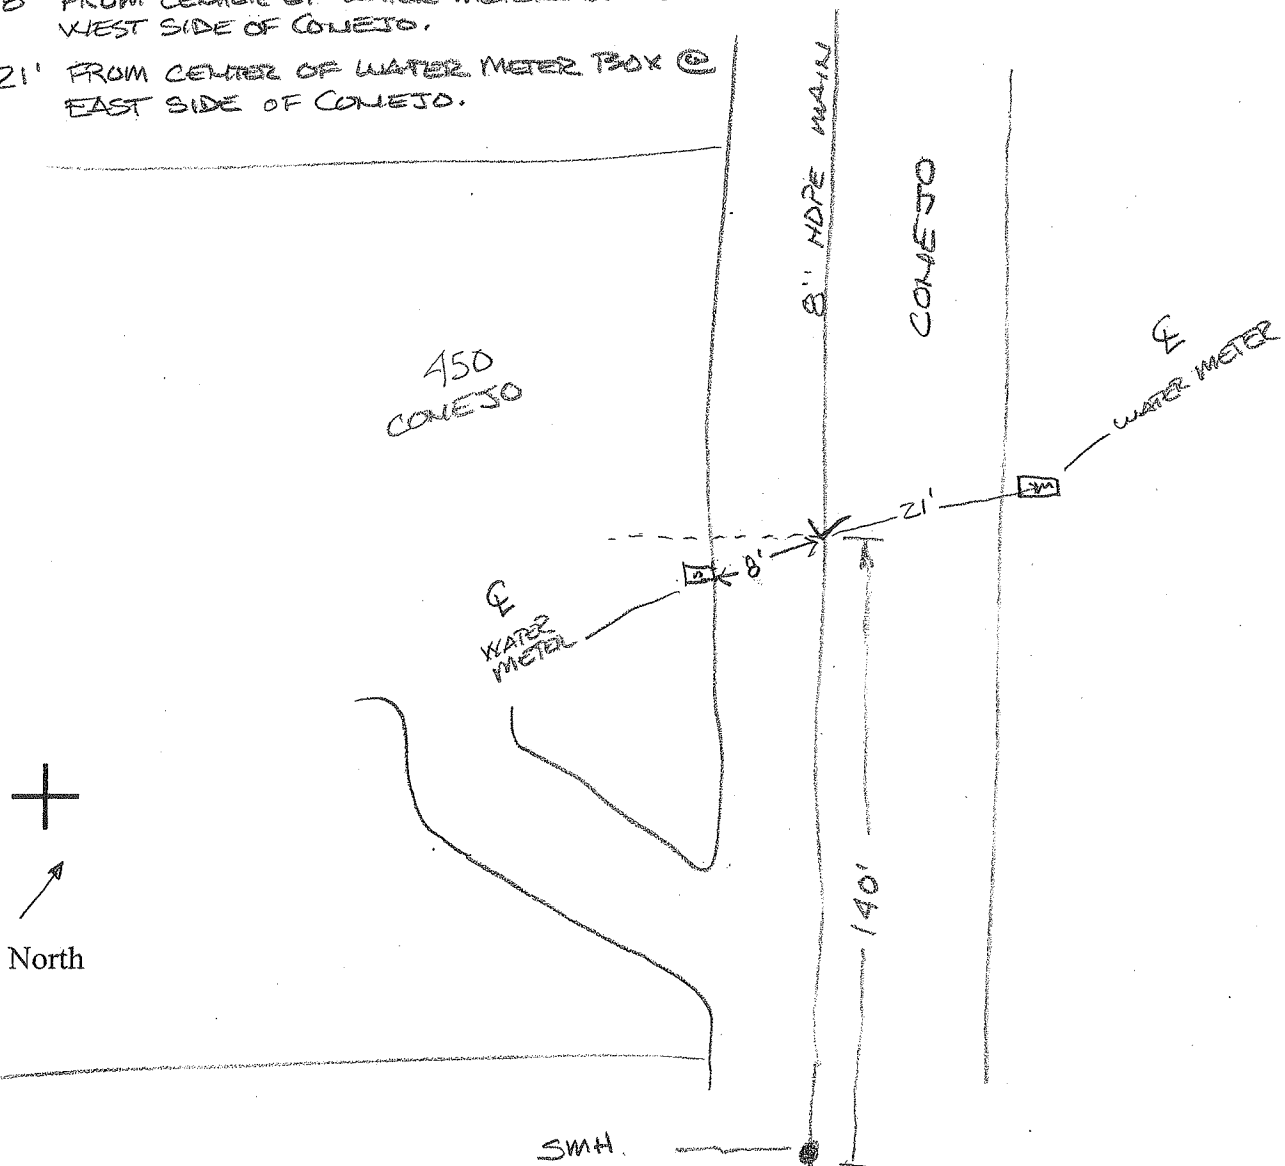
- Date: 12-29-08
- Property Address: 450 CONEJO
- Location/Address of actual excavation (also see diagram attached): SAME
- Size & material type of sewer main: 8" HDPE
- Size & material type of lateral: 4" PVC
- Depth of Wye connection: 6'6"
- Distance of lateral from centerline of downstream manhole: 140'
- Excavation dimensions: 2x4
- Brief description of the site (utility conflict/traffic/soil type/other issues): NONE

140' FROM D.S. SMH

8' FROM CENTER OF WATER METER BOX @
WEST SIDE OF CONEJO.

21' FROM CENTER OF WATER METER BOX @
EAST SIDE OF CONEJO.

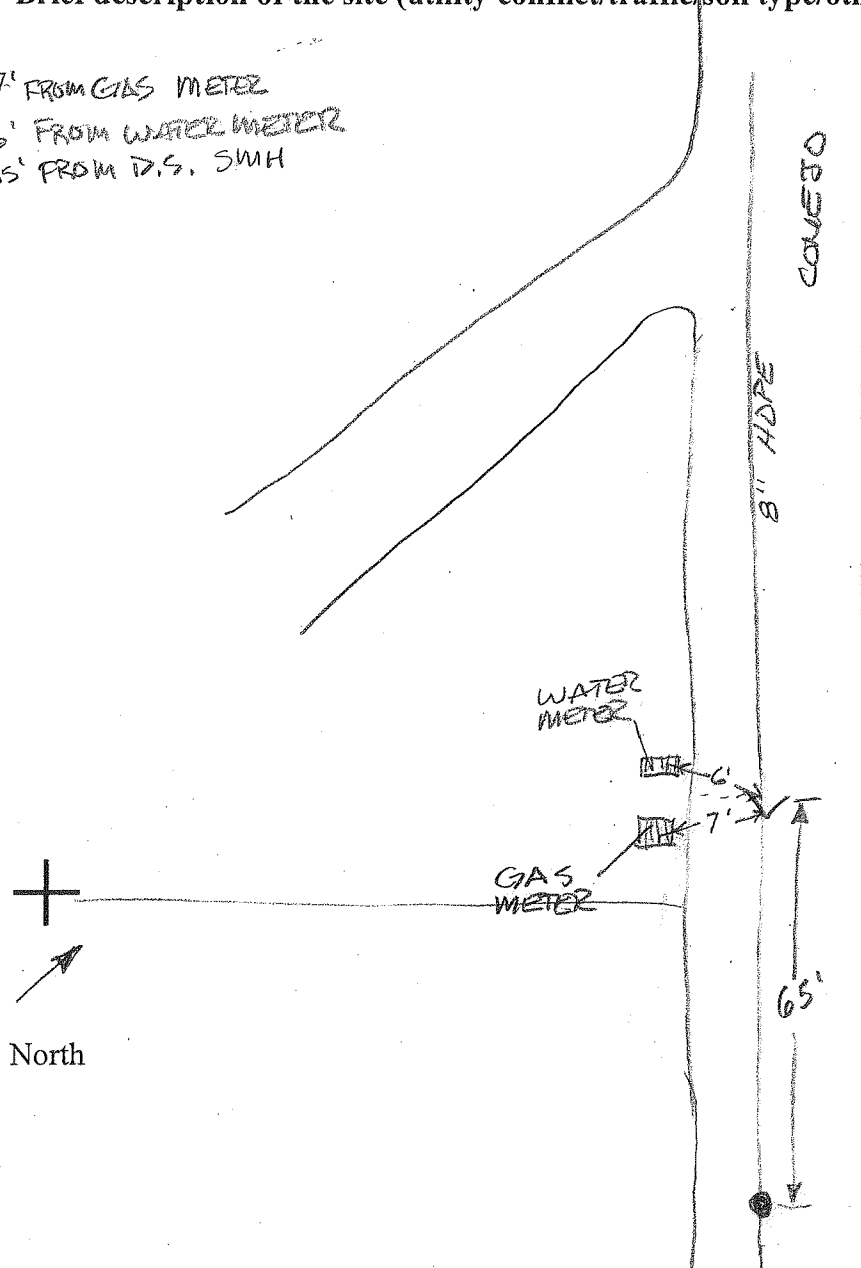
- Date: 12-29-08
- Property Address: 456 CONESO
- Location/Address of actual excavation (also see diagram attached): SAME
- Size & material type of sewer main: 8" HDPE
- Size & material type of lateral: 4" PVC
- Depth of Wye connection: 5' 2"
- Distance of lateral from centerline of downstream manhole: 65'
- Excavation dimensions: 2' x 4'
- Brief description of the site (utility conflict/traffic/soil type/other issues): 3/4" Copper LINE (UNKNOWN WATER GAS) OVER WYE (2' DEPTH)

7' FROM GAS METER
6' FROM WATER METER
65' FROM D.S. SMH

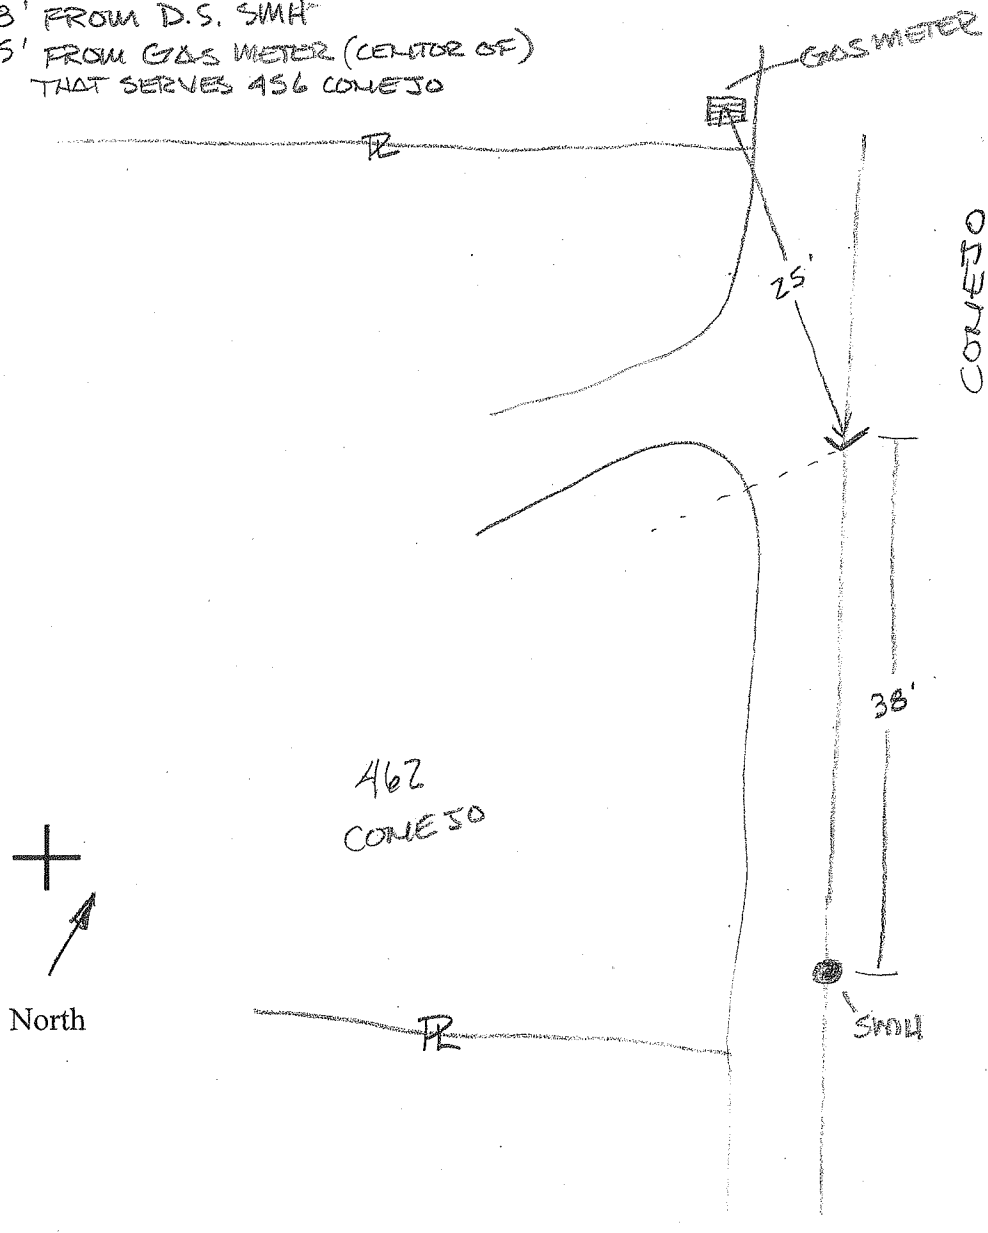
3/4" Copper LINE
(UNKNOWN WATER
GAS) OVER WYE
2' DEPTH

- 38' FROM D.S. SMH
25' FROM GAS METER (CENTER OF)
THAT SERVES 456 CONEJO

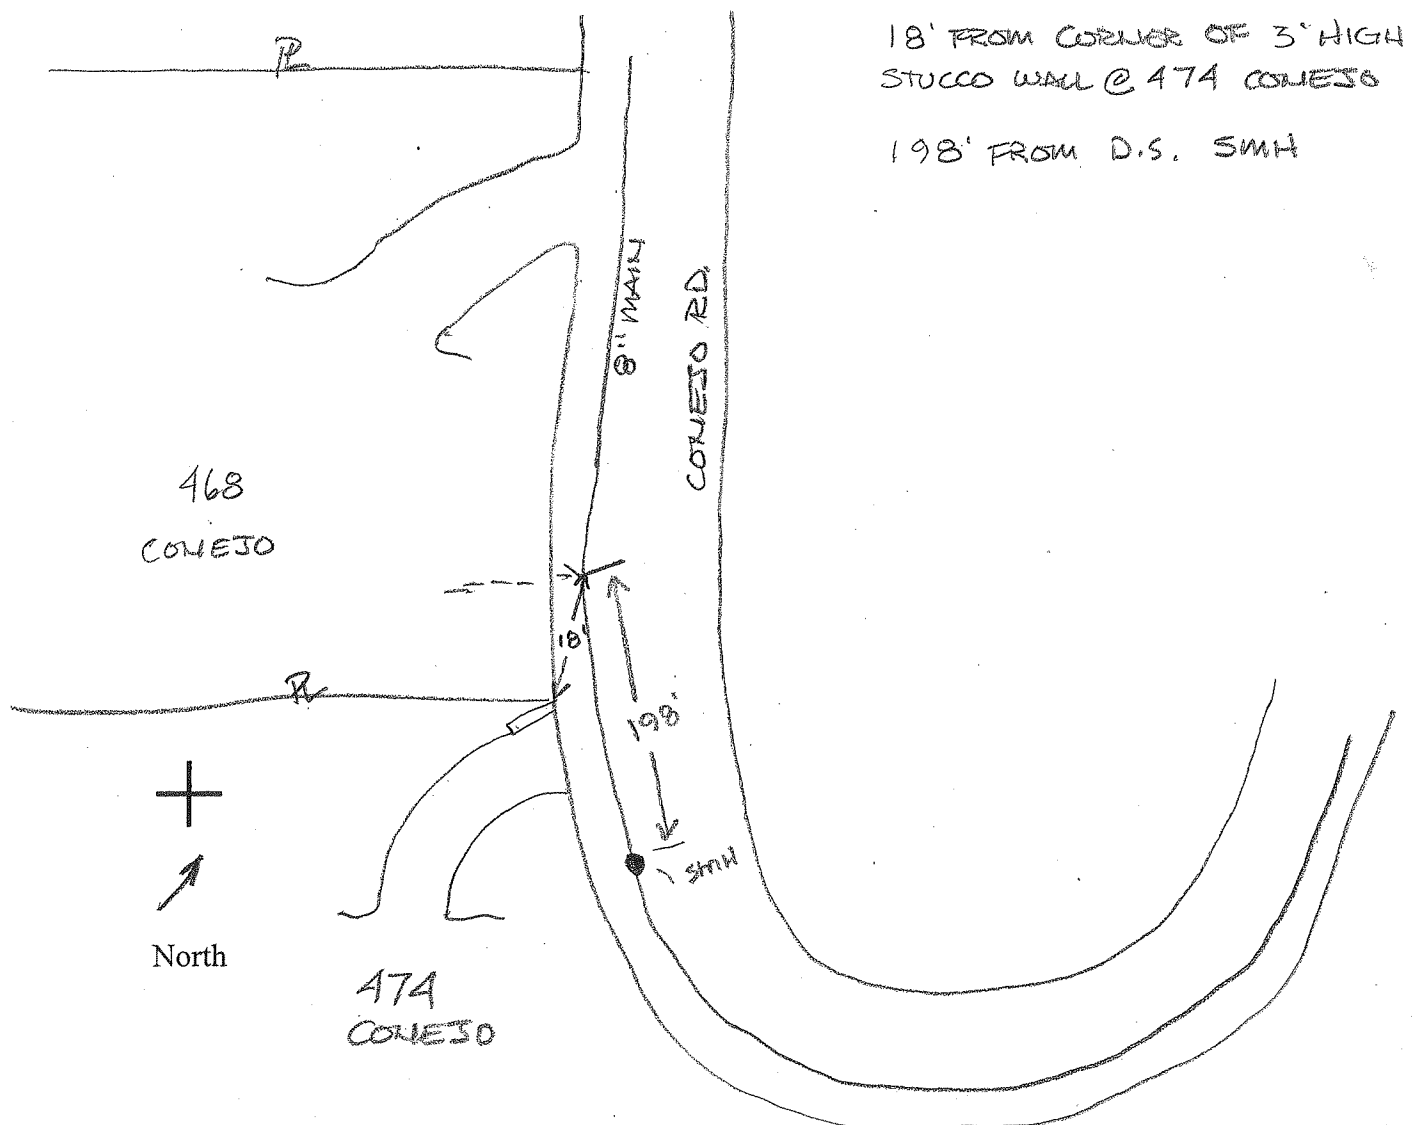
- Date: 12-30-08
- Property Address: 468 Conejo
- Location/Address of actual excavation (also see diagram attached): SAME
- Size & material type of sewer main: 8" HDPE
- Size & material type of lateral: 4" PVC
- Depth of Wye connection: 18"
- Distance of lateral from centerline of downstream manhole:
- Excavation dimensions: 2 x 3
- Brief description of the site (utility conflict/traffic/soil type/other issues): NONE

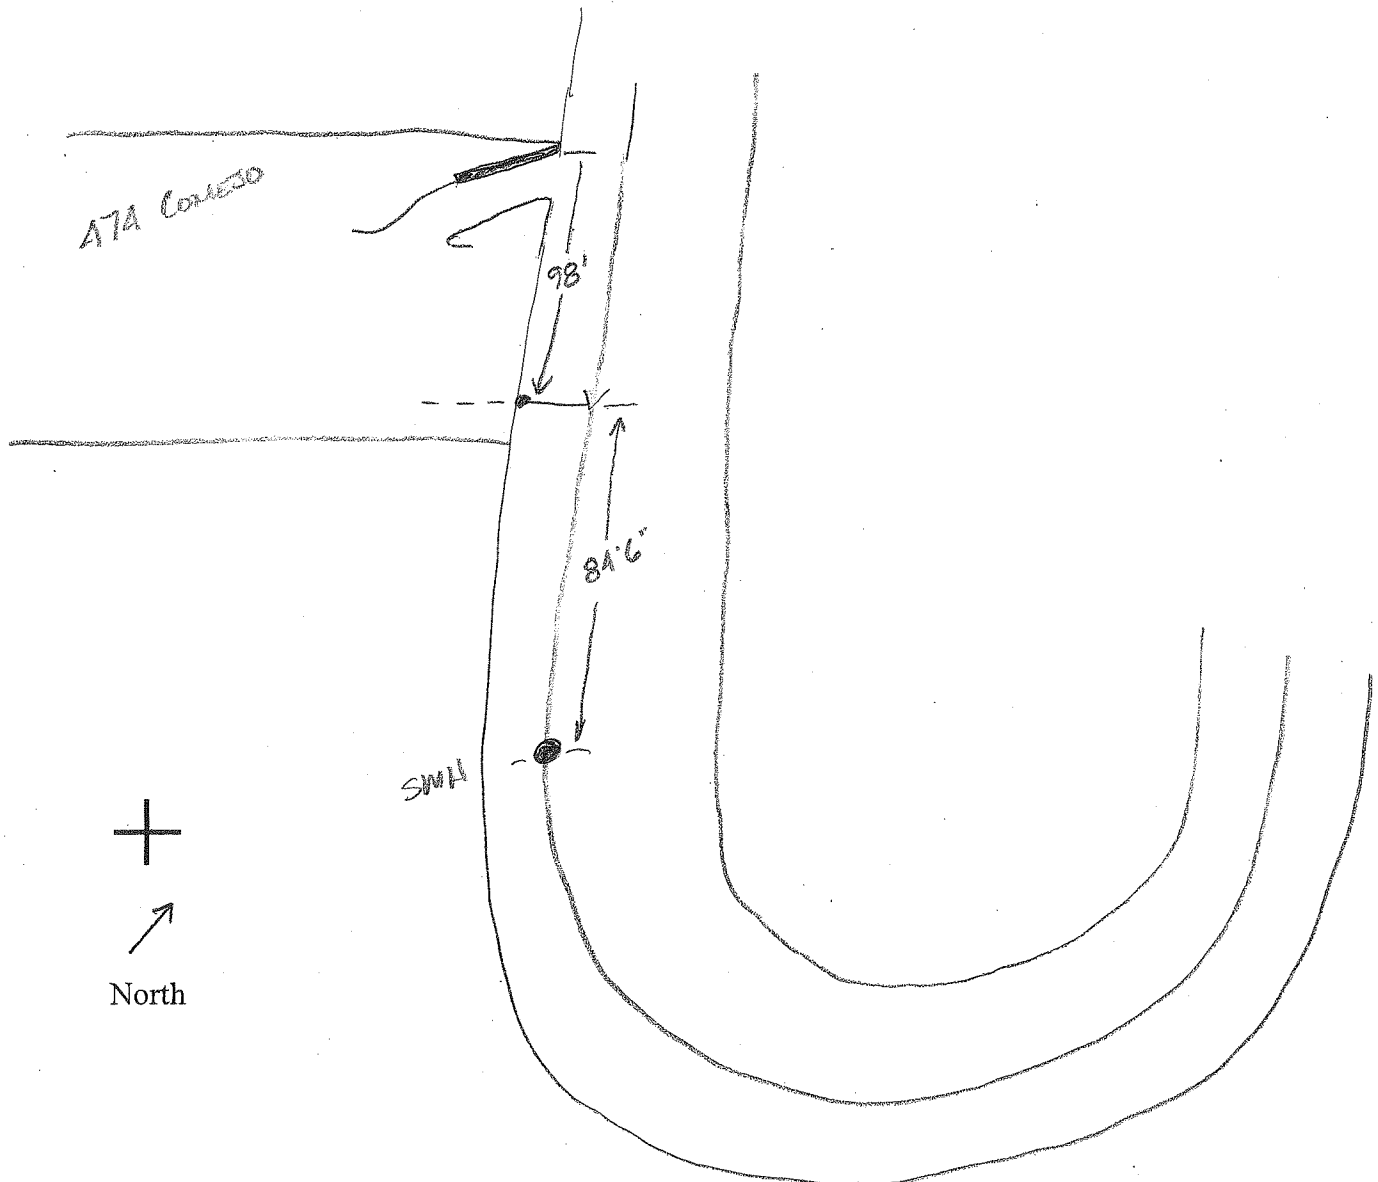
- Date: 12-30-08
- Property Address: 474 CONEJO
- Location/Address of actual excavation (also see diagram attached): SAME
- Size & material type of sewer main: 8" HDPE
- Size & material type of lateral: 4" PVC
- Depth of Wye connection: 18"
- Distance of lateral from centerline of downstream manhole: 84' 6"
- Excavation dimensions: 2 x 2
- Brief description of the site (utility conflict/traffic/soil type/other issues):

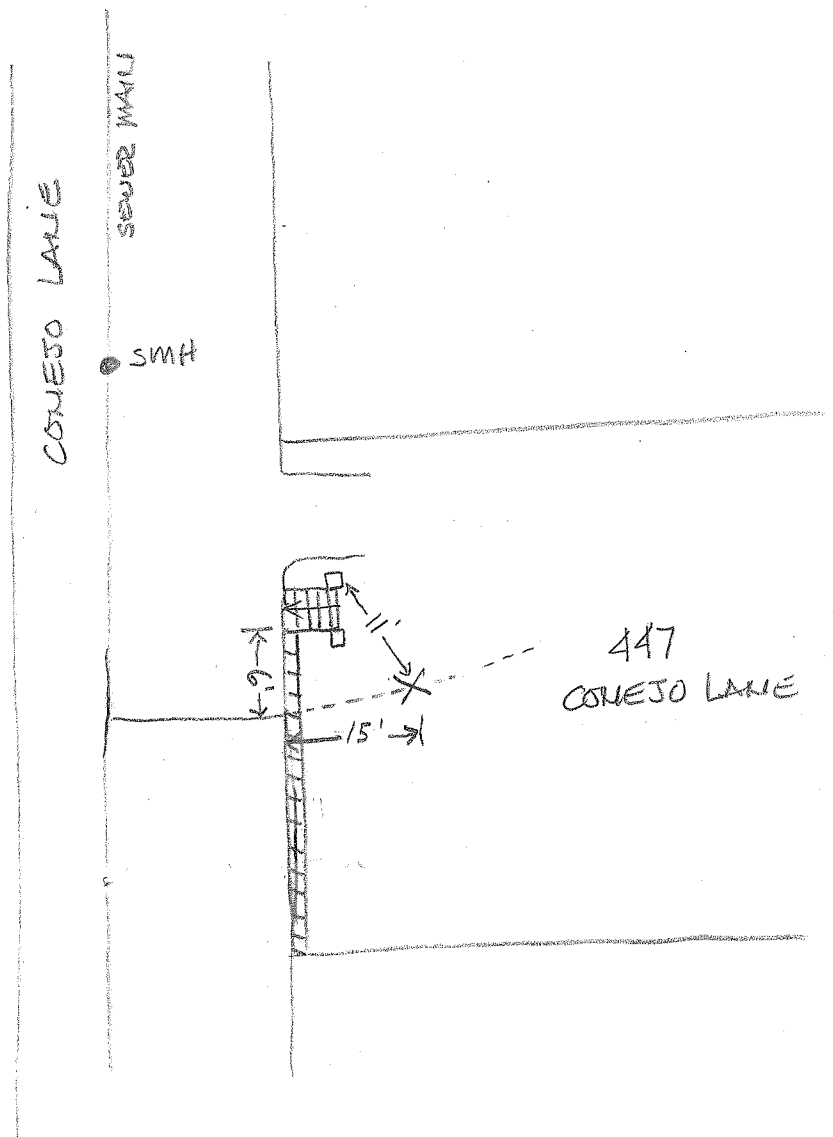
- Date: 1-7-09
- Property Address: 447 CONEJO LN.
- Location/Address of actual excavation (also see diagram attached):
- Size & material type of sewer main: N/A
- Size & material type of lateral: 4" ORANGETOWN (NO SLIP LINE)
- Depth of Wye connection: 30"
- Distance of lateral from centerline of downstream manhole:
- Excavation dimensions: 2 x 2
- Brief description of the site (utility conflict/traffic/soil type/other issues):

15'0" TO FRONT FACE
OF STONE WALL

6' NORTH OF SOUTH SIDE
BEGINNING OF STONE
WALL.

11'0" FROM SOUTH STONE
PILASTER @ GATE AREA

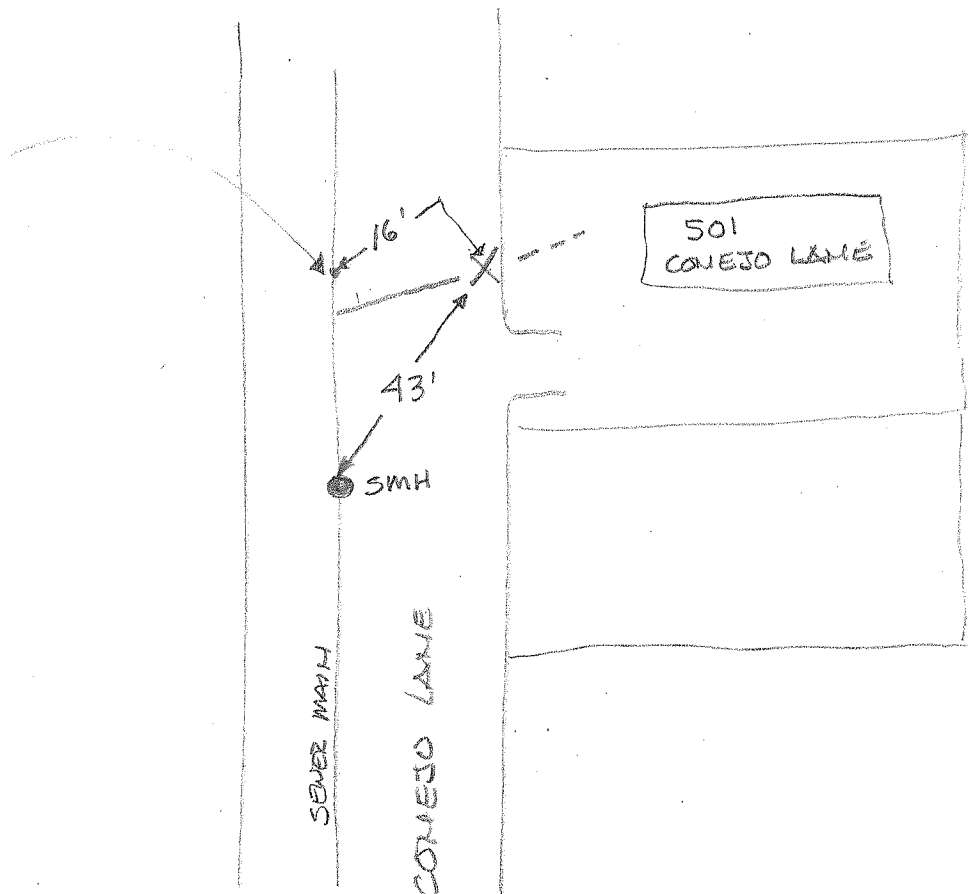
- Date: 1-7-09
- Property Address: 501 CONESO LANE
- Location/Address of actual excavation (also see diagram attached):
- Size & material type of sewer main: N/A
- Size & material type of lateral: 4" ABS
- Depth of ~~Wye~~^{CAP} connection: 4'
- Distance of lateral from centerline of downstream manhole: N/A
- Excavation dimensions: 2x2
- Brief description of the site (utility conflict/traffic/soil type/other issues):

X = CAP

MEDAL TAG &
NAIL IN ROAD

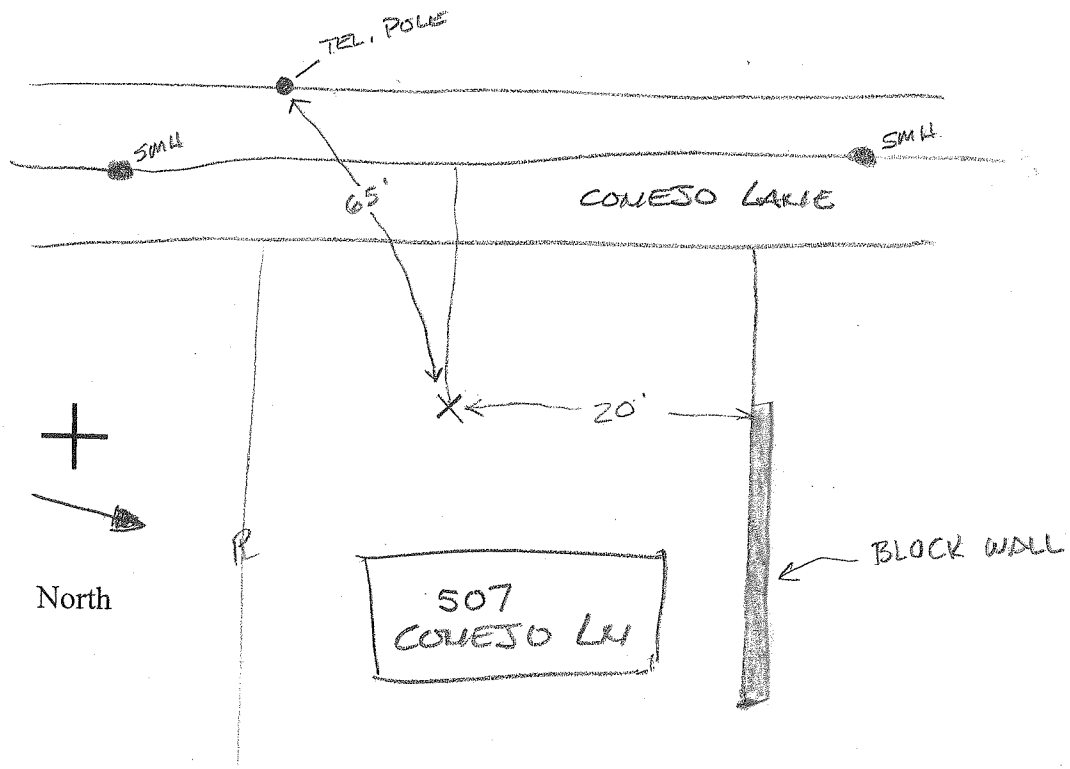
- Date: 1-5-09
- Property Address: 507 CONEJO LANE
- Location/Address of actual excavation (also see diagram attached):
- Size & material type of sewer main:
- Size & material type of lateral: 4" ABS
- Depth of ~~Wye~~ connection: 18" TO CAP
- Distance of lateral from centerline of downstream manhole:
- Excavation dimensions:
- Brief description of the site (utility conflict/traffic/soil type/other issues):

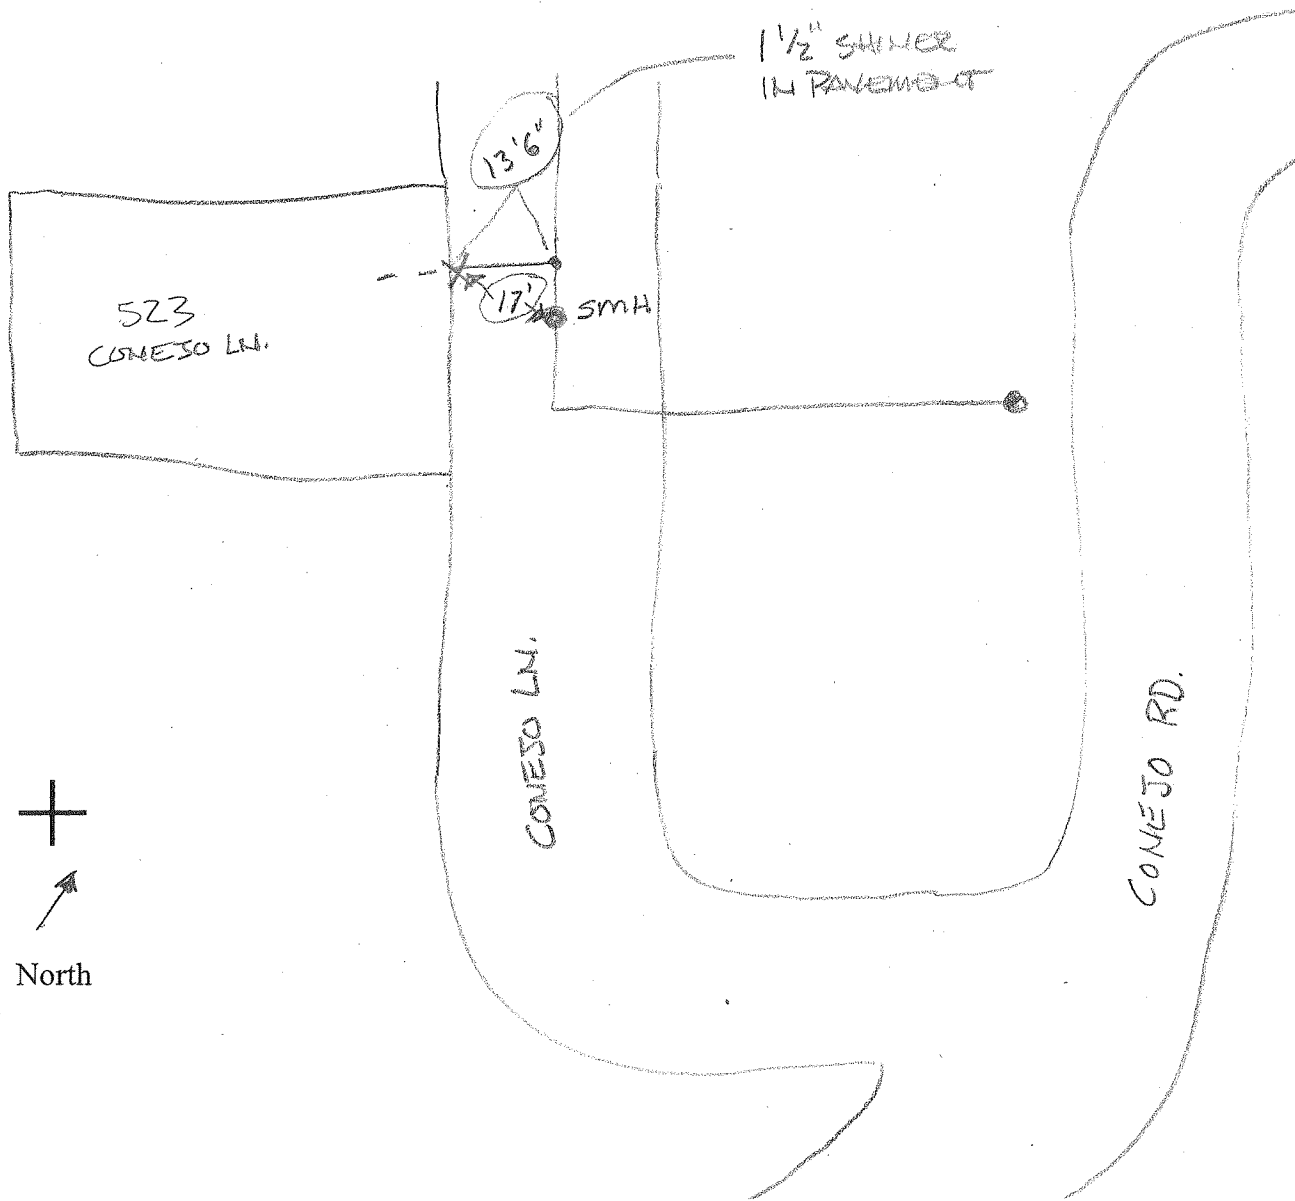
- Date: 1-6-09
- Property Address: 523 CONESO LANE
- Location/Address of actual excavation (also see diagram attached): SAME
- Size & material type of sewer main: UNKNOWN
- Size & material type of lateral: 4" ORANBURG/SUPLINED
- Depth of ~~Wye~~^{CAP} connection: 3'6"
- Distance of lateral from centerline of downstream manhole: 9'0"
- Excavation dimensions: 4 x 2
- Brief description of the site (utility conflict/traffic/soil type/other issues): PLUGGED W/
CONCRETE

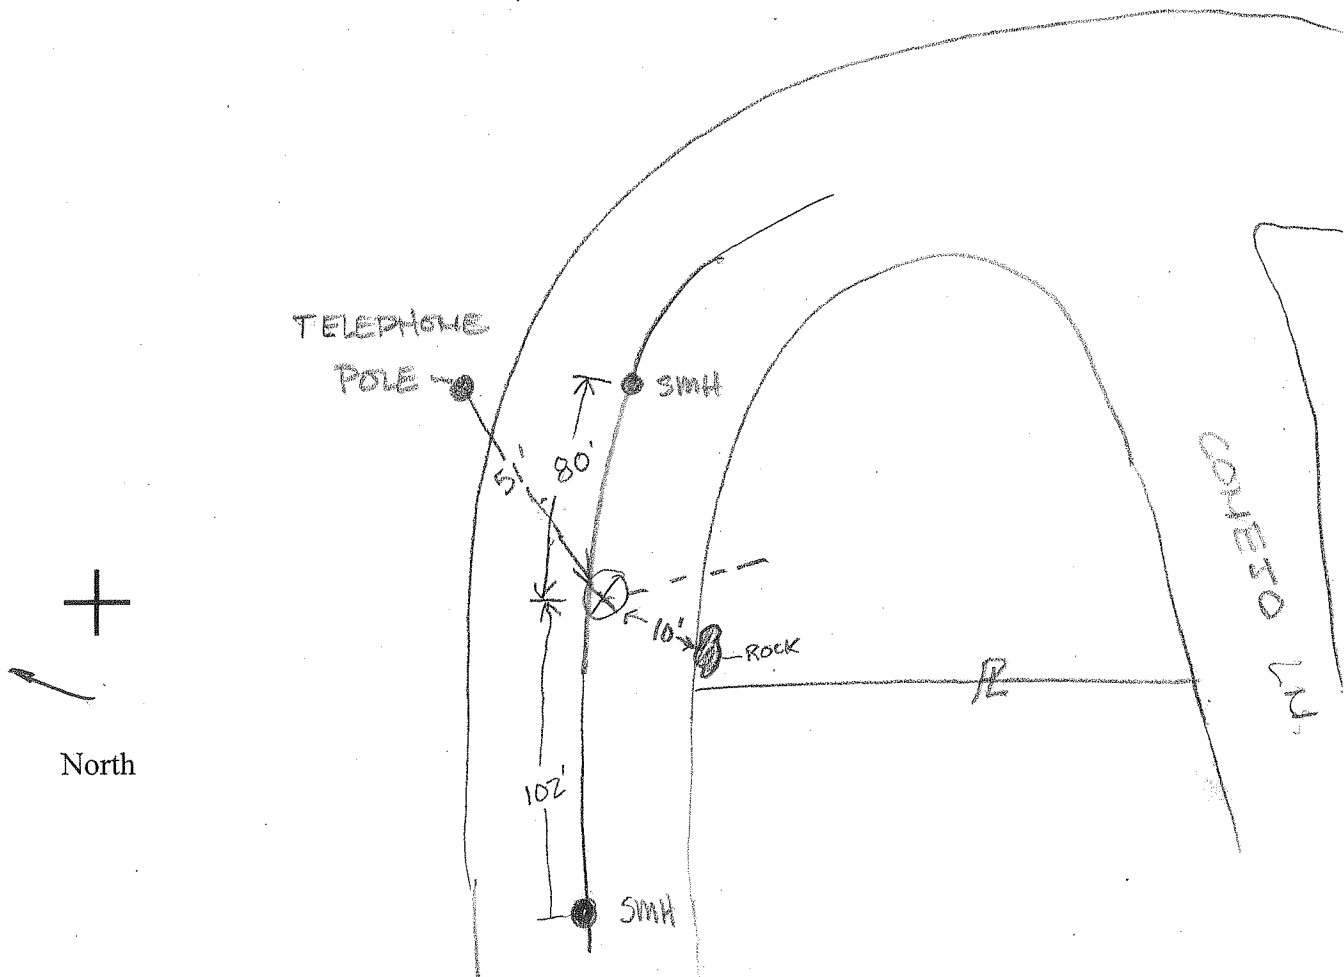
- Date: 1-14-09
- Property Address: 525 CONESO LANE
- Location/Address of actual excavation (also see diagram attached):
- Size & material type of sewer main: CLAY
- Size & material type of lateral:
- Depth of Wye connection: 5'6"
- Distance of lateral from centerline of downstream manhole: 102'
- Excavation dimensions: 2x4
- Brief description of the site (utility conflict/traffic/soil type/other issues): CLAY WYE
(BAD ALIGNMENT)

⊗ = PLUG

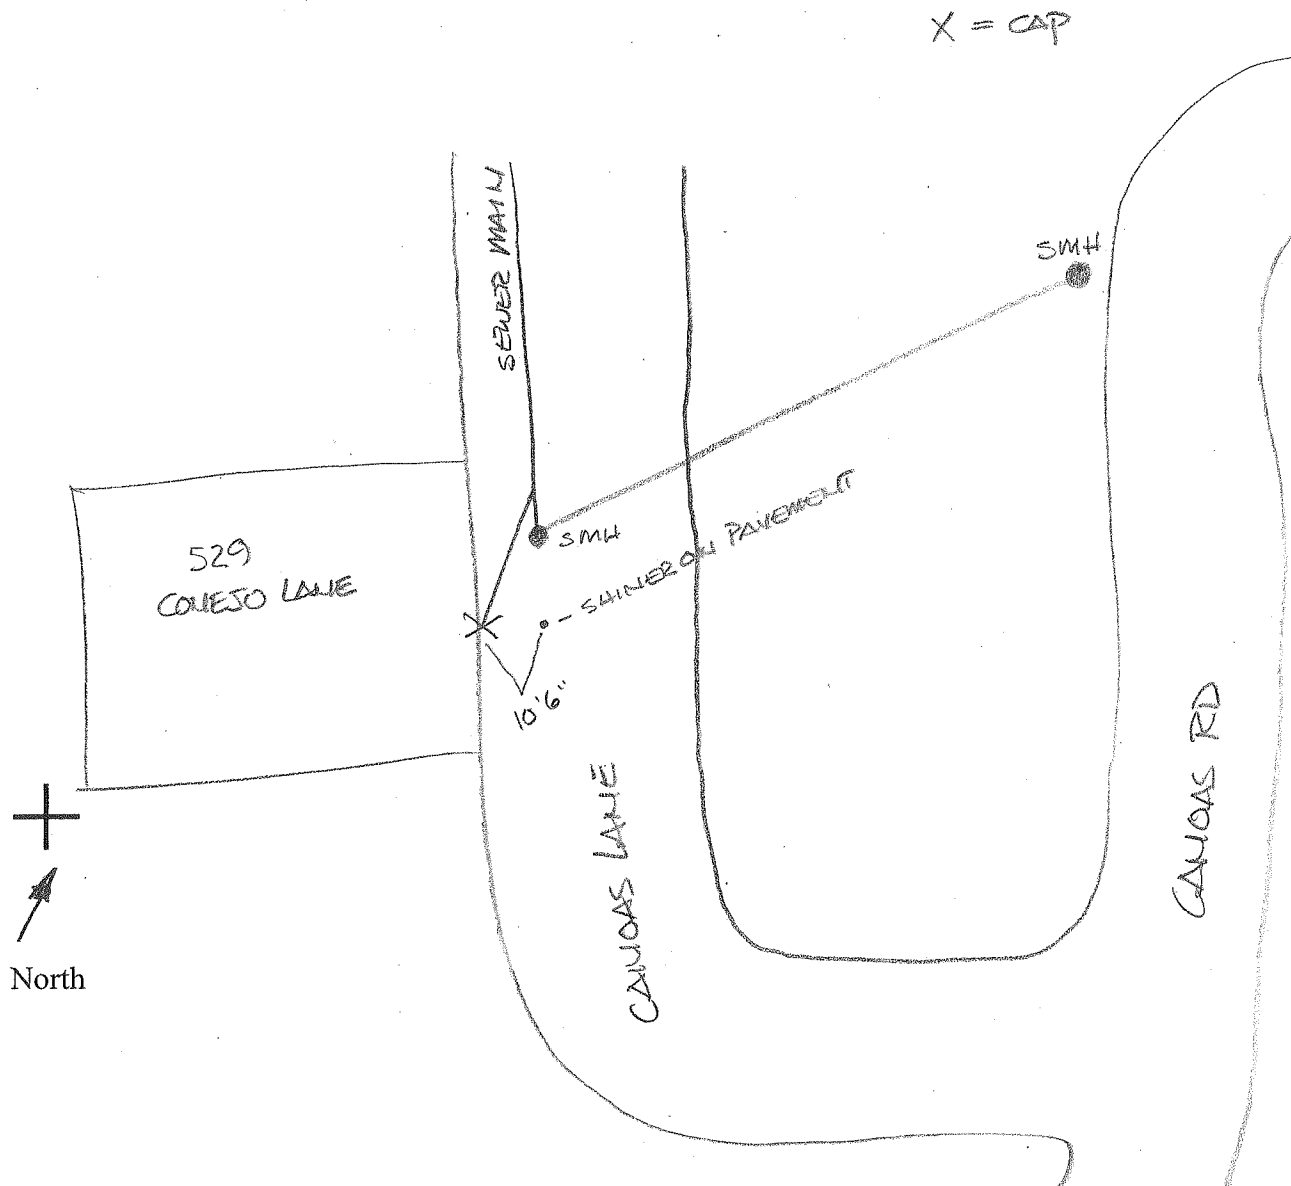
- Date: 1-6-09
- Property Address: 529 CONESO LN
- Location/Address of actual excavation (also see diagram attached): SAME
- Size & material type of sewer main: N/A
- Size & material type of lateral: ORANGEBURG/SUPLINED
- Depth of ^{CAP}Wye connection: 3'
- Distance of lateral from centerline of downstream manhole: N/A
- Excavation dimensions: 2 x 2
- Brief description of the site (utility conflict/traffic/soil type/other issues): NONE

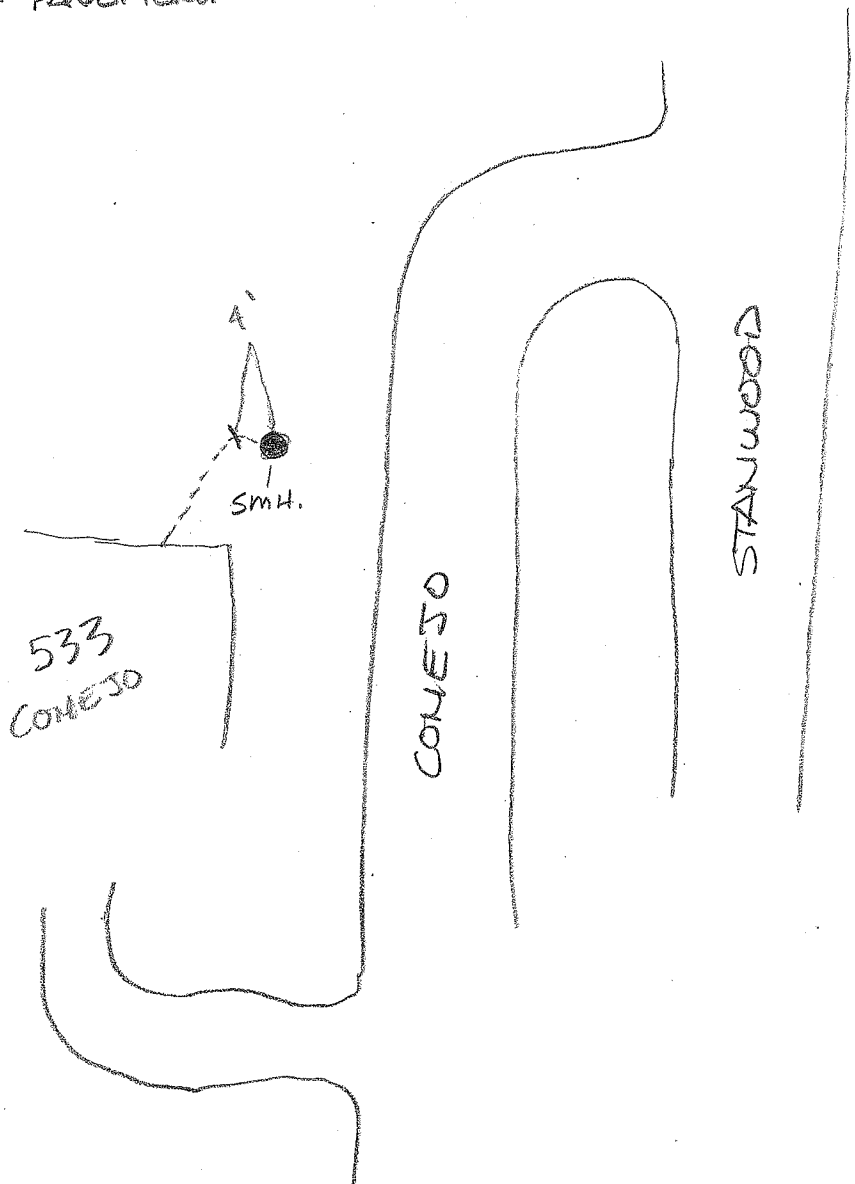
- Date: 12-19-08
- Property Address: 533 CONESO
- Location/Address of actual excavation (also see diagram attached): EASEMENT
- Size & material type of sewer main: 6" CLAY
- Size & material type of lateral: 4" ABS
- Depth of Wye connection: 3'
- Distance of lateral from centerline of downstream manhole: 4'
- Excavation dimensions: 3' x 3'
- Brief description of the site (utility conflict/traffic/soil type/other issues):

40' WEST OF EDGE OF PAVEMENT

4' WEST OF SMH

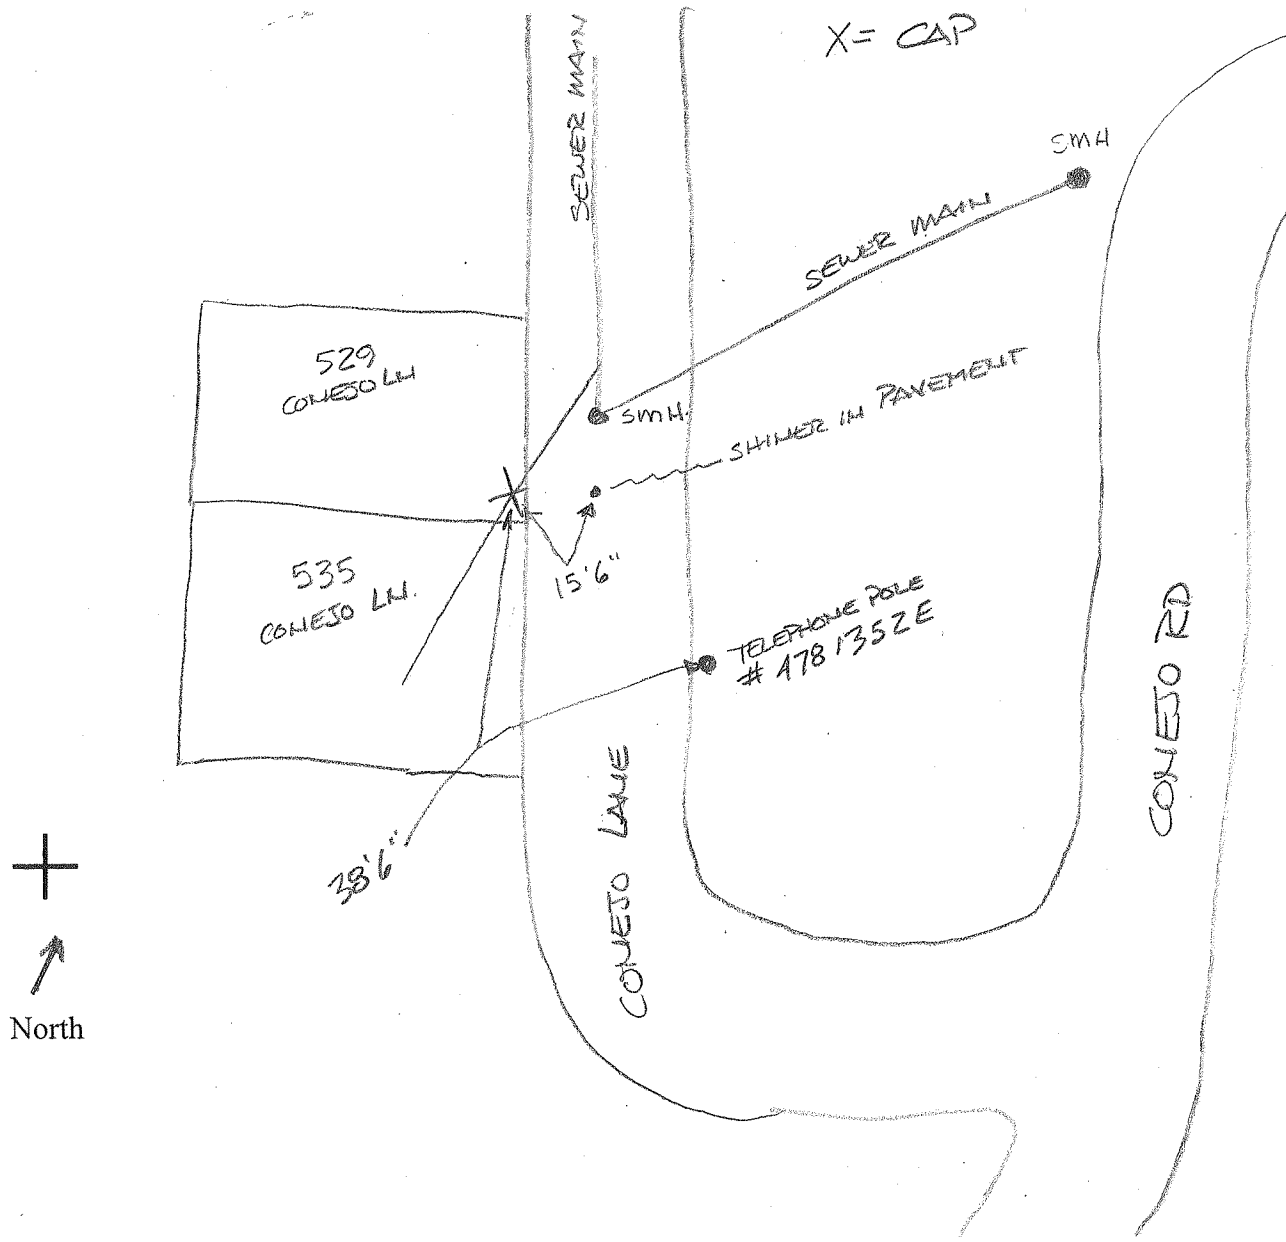
- Date: 1-6-09
- Property Address: 535 CONESO LN.
- Location/Address of actual excavation (also see diagram attached):
- Size & material type of sewer main:
- Size & material type of lateral: ORANGEBURG / SLIP LINED
- Depth of ^{CAP} ~~Wye~~ connection:
- Distance of lateral from centerline of downstream manhole:
- Excavation dimensions:
- Brief description of the site (utility conflict/traffic/soil type/other issues):

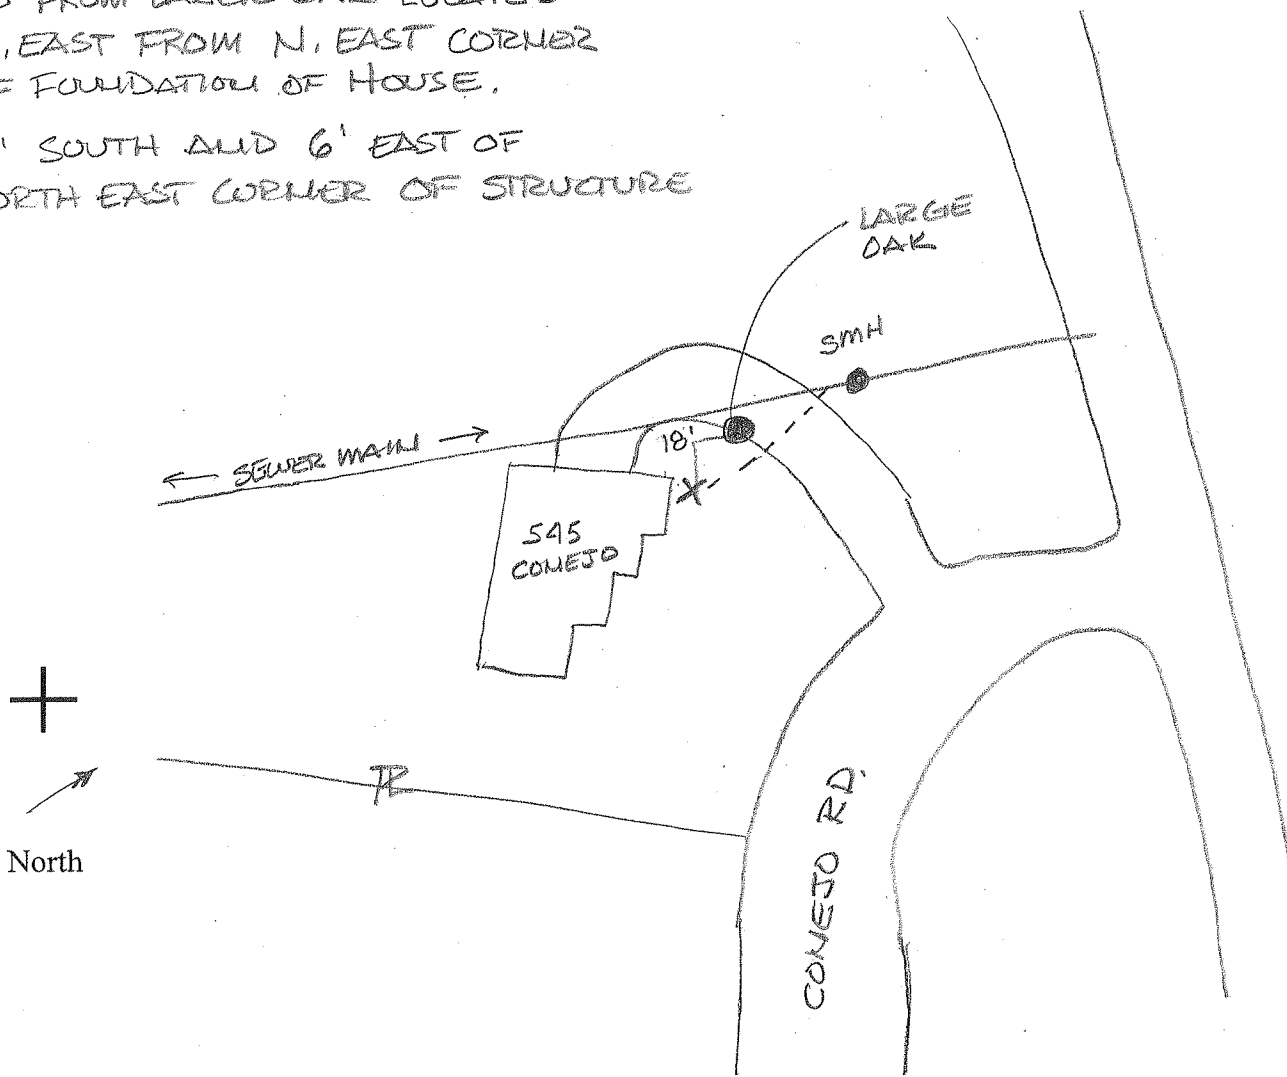
- Date: 1-8-09
- Property Address: 545 CONEJO
- Location/Address of actual excavation (also see diagram attached): SEE BELOW
- Size & material type of sewer main: N/A
- Size & material type of lateral: 4" CLAY
- Depth of ^{CAP}Wye connection:
- Distance of lateral from centerline of downstream manhole: 51' ±
- Excavation dimensions: 2X2
- Brief description of the site (utility conflict/traffic/soil type/other issues): NONE

X = CAP

- 1) 18' FROM LARGE OAK LOCATED N, EAST FROM N, EAST CORNER OF FOUNDATION OF HOUSE.
- 2) 5' SOUTH AND 6' EAST OF NORTH EAST CORNER OF STRUCTURE
